Article

Correlation of Vulnerability and Damage between Artistic Assets and Structural Elements: The DataBAES Archive for the Conservation Planning of CH Masonry Buildings in Seismic Areas

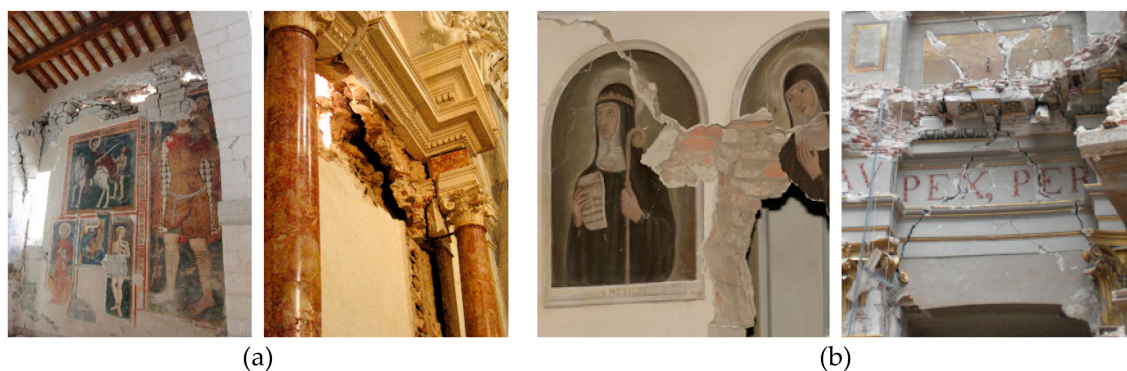
Figure 1. Examples of damage of artworks due to out-of-plane (a) and in-plane (b) mechanisms for frescoes and stuccoes.

As an example, a typical severe and, unfortunately, common condition is that of a fresco borne by a wall that has no constraints (e.g., ties, effective connections with adjacent walls and the floor/roof) to counteract overturning under seismic loads, or has low masonry quality (e.g., multi-leaf rubble section). The fresco is in the highest risk condition, because the structural element (the wall to which the fresco is connected) behaves according to the weakest and most brittle mechanism (i.e., out-of-plane collapse) (Figure 1a). On the contrary, in a building where the activation of overall behaviour is provided by more earthquake-resistant conditions, limited structural damage is expected (e.g., in-plane shear cracking in a wall), although it can provide severe patterns, which could affect the fresco integrity (Figure 1b).

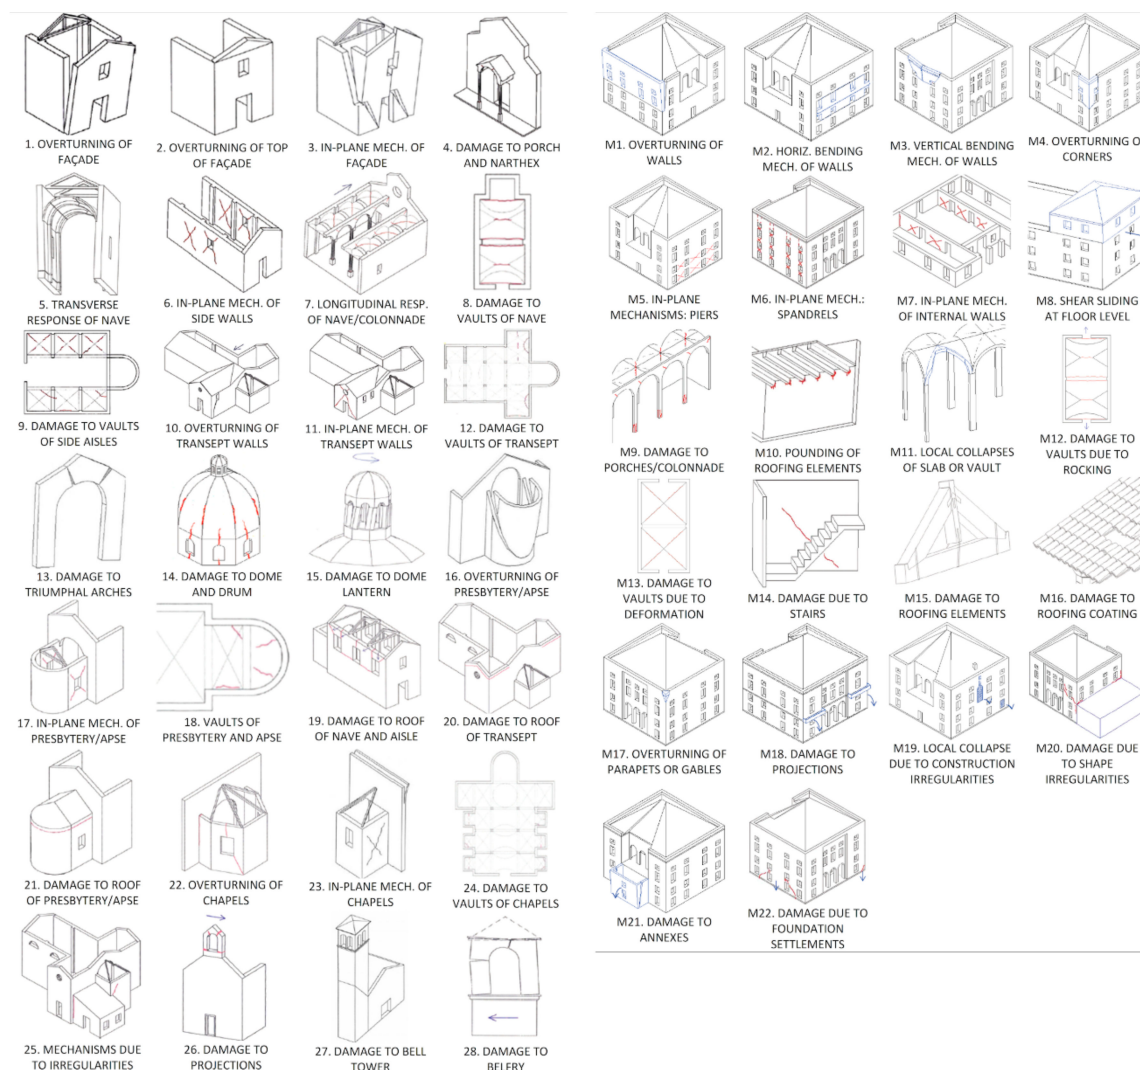
Figure 3. Example of mechanisms for masonry churches and buildings adopted in DataBAES forms, as shown in church (A-DC, 28 mechanisms) [19] and palace (B-DP, 22 mechanisms) [20] survey forms.

For the primary mechanisms, additional data can be provided about in-plane or out-of-plane damage details for walls (e.g., overturning activation, spalling, crushing, or collapse), as well as about the extension of potential cracking for vaults and columns. Details on cracking are also included, since these can affect the integrity of the AA in terms of extension and type (crazing, passing through, rough estimation of crack opening, etc.). At level I, damage evaluation is predominant, hence the presence of vulnerability indicators and of earthquake-proof devices is simply declared and kept as an overall recognition of potential additional issues for the building.

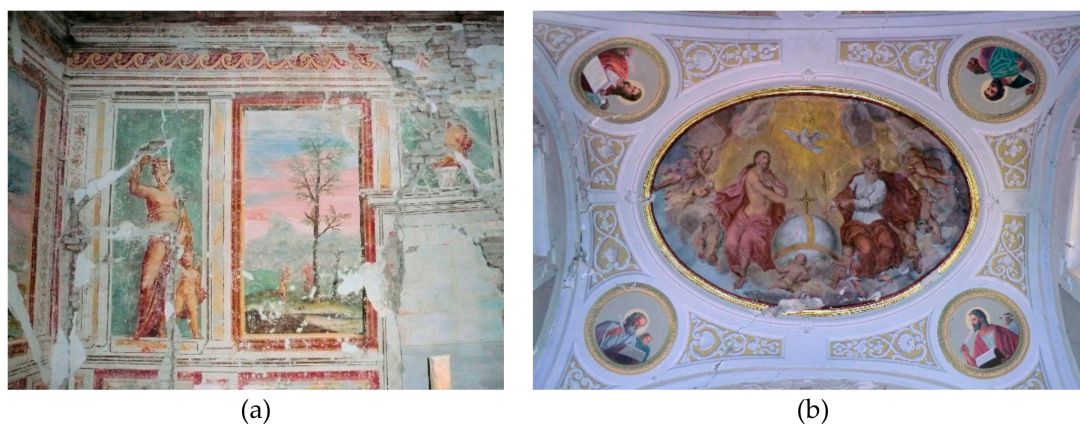
Figure 5. Example of primary and secondary mechanisms associated with a damaged fresco located in apse of a church: (a) apse is subjected to ‘overturning’, but the main mechanism affecting fresco is ‘shear’; therefore, ‘in-plane mechanism of apse’ and ‘overturning of apse’ are, respectively, primary and secondary mechanisms; (b) damage to the vault of the central nave affects the painting as a primary mechanism.

At level II, the form requires the identification of the AA and its related SE with the primary or secondary mechanism having already been identified (Figure 5). In fact, at this level, each of the 28 mechanisms for churches or the 22 mechanisms for the other types of buildings are analysed in detail, both in terms of damage and the presence of specific vulnerability/devices. In the case of non-structural elements supporting artworks (e.g., *camorcanna* vaults), the mechanism should be identified as that of the macro-element, which could affect the one of the non-structural elements in question (e.g., the possible overturning of walls supporting the *camorcanna* vault). For the increasing damage evaluation, a grade from 1 to 5 is required, whereas for the vulnerability assessment the increasing overall scale of 1 to 5 is derived from the detailed evaluation of each item based on a three-grade scale, according to the effectiveness of potentially good construction details and/or earthquake-proof systems (e.g., ties, buttresses, connections and anchors, light bracing, and lintels). This scale corresponds to ‘ineffective’ (any check box marked), ‘moderate’ (grade 1), ‘good’ (grade 2), and ‘completely effective’ (grade 3). Vulnerability concerns the presence of thrusting elements (roof struts, arches, and vaults), slender piers, large openings close to corners, stiff ridge beams, heavy floors/roof, high-span thin vaults, etc., and is expressed on the scale of 1 to 5 corresponding to the grades ‘very low’–‘low’–‘average’–‘high’–‘very high’.

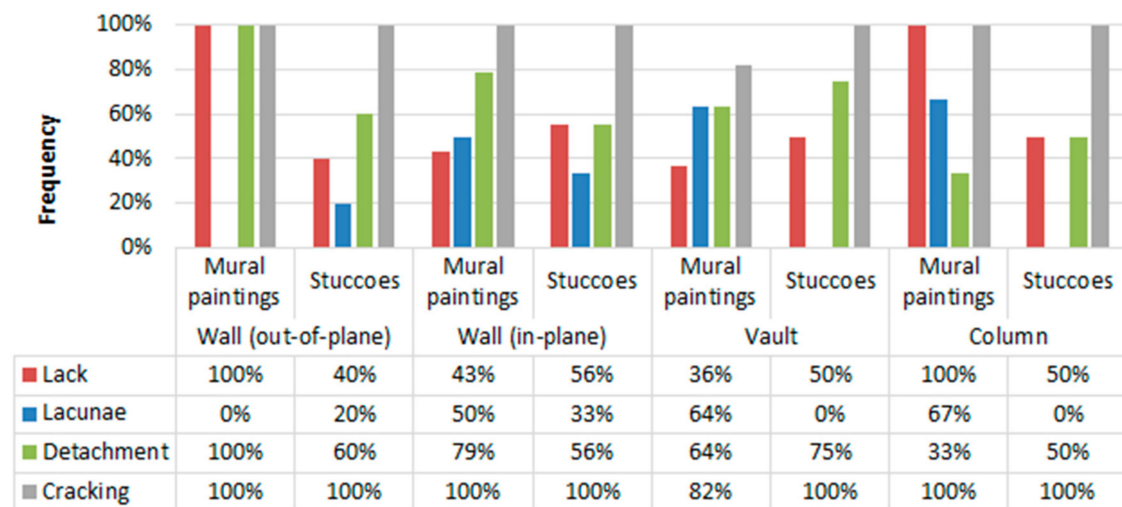
Figure 11. Frequency of the occurrence of the deterioration types of AA combined with mechanisms of SE detected for mural paintings and stuccoes.

The combination of the case studies representing mural paintings (30 case studies) and stuccoes (20 case studies) in the buildings allowed preliminary elaborations of data regarding the frequency of the occurrence of the deterioration of AA in relation to the mechanisms of their supporting SE. The majority of case studies detected in the buildings referred to the in-plane damage of the walls, for either mural paintings or stuccoes, followed by the damage of the vaults and the out-of-plane mechanisms of walls, respectively, for mural paintings and stuccoes. Figure 11 shows the results obtained for the artworks detected in the buildings. Most deterioration for AA refers to cracking and detachment, either for the cases of mural paintings or stuccoes. Especially in mural paintings, the *lacunae* are not connected to out-of-plane mechanisms, as they do not involve substrate layers;

on the contrary, as expected, *lacunae* are more frequent in the case of in-plane mechanisms. Lack and detachment particularly affect the stuccoes, due to loss of the material of their typical slender protruding portions.

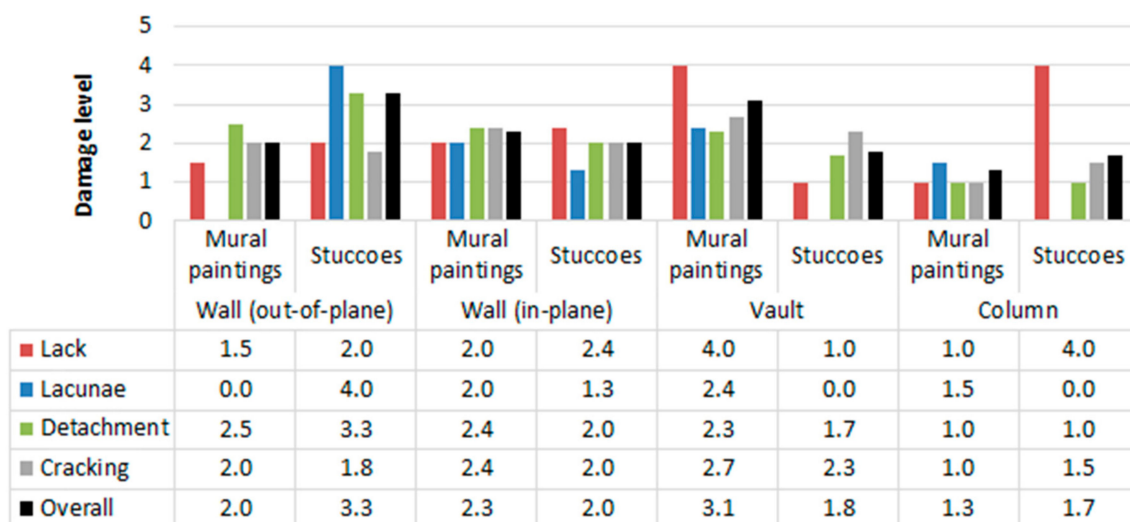
Figure 12. Average damage levels of AA combined with mechanisms of SE identified for mural paintings and stuccoes.

Figure 12 shows the evaluation of average damage according to the indications of the II level survey form, performed for both mural paintings and stuccoes, as well as an overall judgment encompassing the condition of the structural macro-element (i.e., wall, vault, or column). The highest values of average damage (higher than 2) mainly refer to the out-of-plane mechanisms of walls for stuccoes, and the damage of the vaults, followed by the in-plane damage of the walls, for mural paintings.

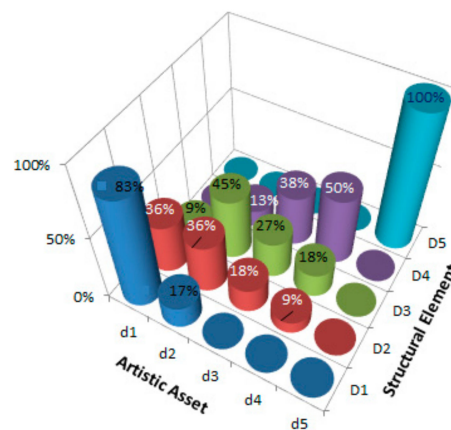
Figure 13. Distribution of the damage levels of AA versus each degree of SE damage.

The analysis of the levels of overall damage associated with the macro-element supporting each artistic asset provided the distributions given in Figure 13. The results refer to the overall damage of both mural paintings and stuccoes and are based on the assumption that the damage of the AA (d1, d2, ..., d5) is induced by that of the SE (D1, D2, ..., D5) [24]. In general, the increase of damage in AA corresponds to an increasing damage in the supporting SE, with significant distribution at D2–D3 levels, i.e., from moderate (D2) to substantial to heavy damage (D3).

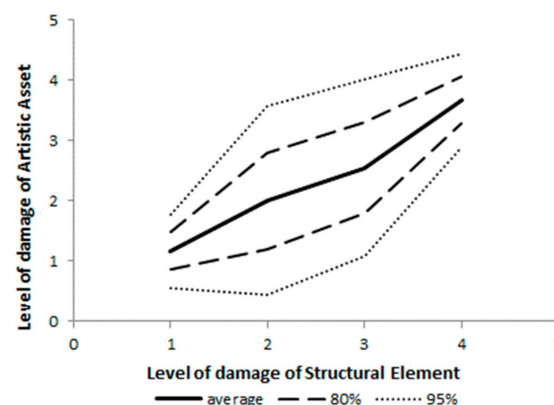
Figure 14. Joint distribution of damage levels between AA and SE for both mural paintings and stuccoes.

The same trend is expressed by the curves in Figure 14, which better clarify the strong correlation between the damage of AA and SE.
